CITY OF BATH

Bath, Maine PROJECT #20394

October 15, 2020

Fire and Police Facility Study

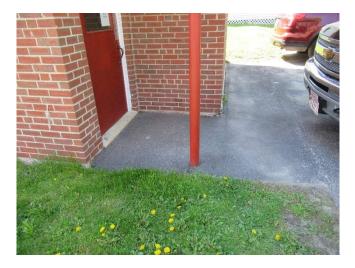
The site is comprised or two distinctly different pavement conditions. The front driveway and apron are asphalt that was last paved 20 years ago and is in poor condition. The pavement joints have settled and run the entire length of the drive from High St. to the apparatus bays. Exacerbating the situation is number of pavement joints created by the use of residential scale machinery to place the asphalt. There are pot holes near the building creating hazards to pedestrian. There is no concrete pavement for the apparatus or service bay aprons.

- 1. Separate stormwater and sanitary sewer.
- 2. Provide concrete slabs at doorways
- 3. Regrade snow storage areas to avoid meltwater runoff onto adjacent properties.

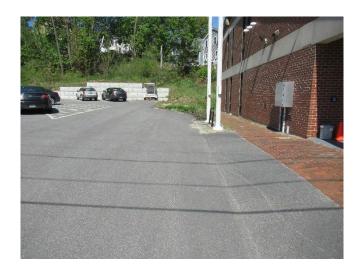
All parking lot pavement and driveways are asphalt. The rear parking lot is in fair condition; the municipal parking lot is in good condition. The brick sidewalk from Water St. to the main entrance is in fair condition with some uneven pavers.

- 1. Repair and/ or repave the rear parking area.
- 2. Repair and reset the brick sidewalk.
- 3. Provide an accessible curb ramp to the municipal parking lot in lieu of the slope asphalt esplanade.

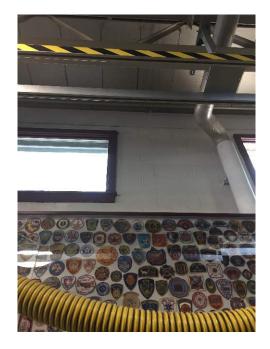
Structural: Exterior walls on both sides of the apparatus bay were observed to have significant cracking and upper windows appeard to be out of plumb.

Crack above apparatus bay windows

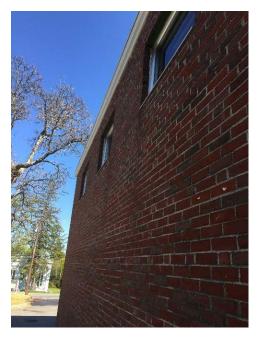
Exterior: windows out of plumb

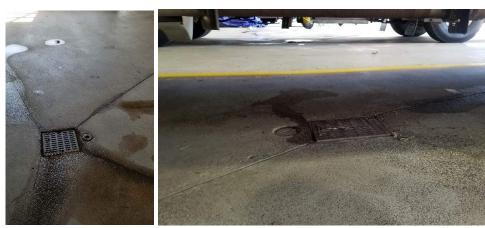
Each garage truck bay has a single centered oil and sand separator floor drain with integral cleanout. The drain line still experiences a fair amount of debris which causes problems with drainage.

Garage Floor Drains

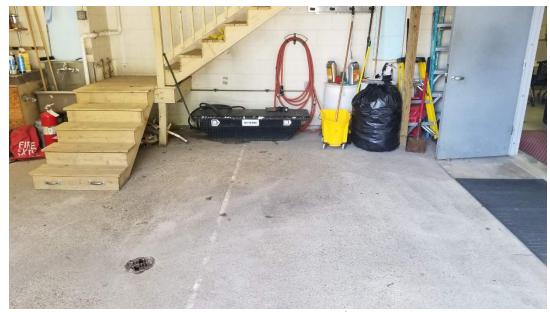
There is one floor drain in the garage with a damaged grate. The floor drain collects vehicle wash water which can contain sand. An oil/sand separator is not present to capture sand or oil.

Floor Drain with Service Sink, Condensate Drain from Air Handlers

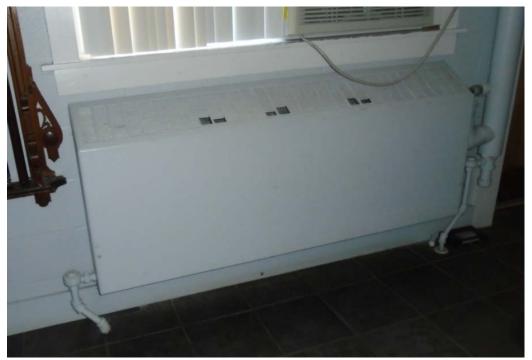
It was reported that temperature control throughout the building is poor. During the shoulder season, the temperature fluctuates dramatically from too cold to too hot. During low ambient temperatures, the indoor temperatures fluctuate less since the boiler runs continuously.

Typical Steam Radiator

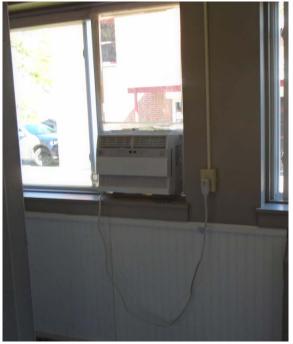
Air conditioning is provided by ten window units installed throughout the building. The largest of the units is 12,500 BTU/hour, another unit is 9,000 BTU/hour and the remaining eight are 6,000 BTU/hour. The units are installed in the horizontal sliding windows with a section of plexiglass above to hold in place and provides minimal air barrier to the outside.

Window AC installed in the hallway outside of the bedrooms

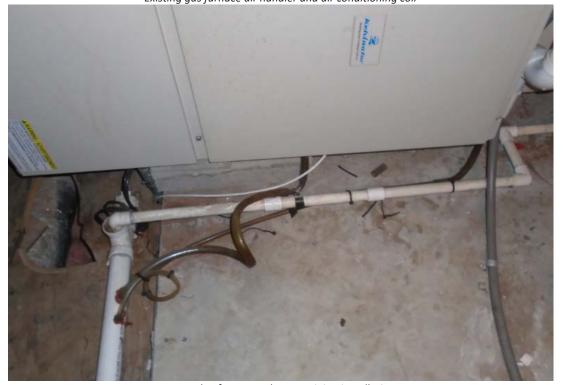
Example of poor condensate piping installation

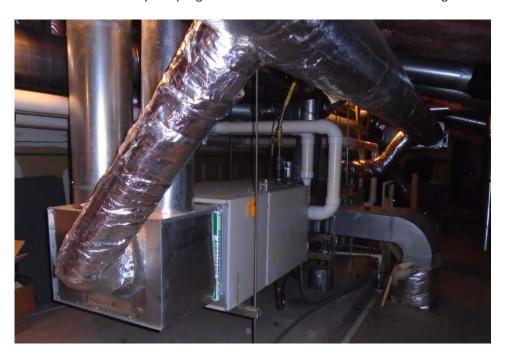
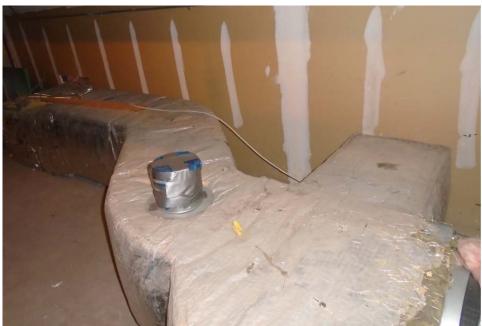
Heating and cooling is distributed throughout the building through ductwork. Ductwork is mostly insulated in the attic but there are some sections where modifications to the ductwork was conducted and insulation was not replaced. There are three zones for the first floor and the second floor is the fourth zone. Honeywell programmable thermostats are installed throughout.

Examples of ductwork in attic

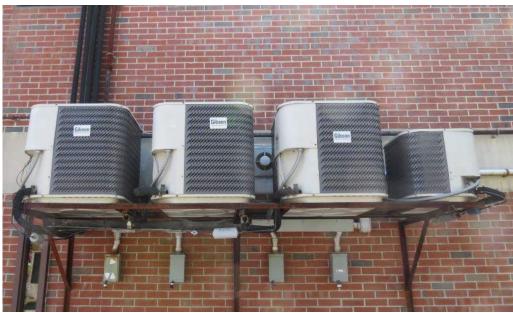
Four air conditioning compressors are mounted on the rear of the building. These R-22 refrigerant systems were manufactured by Gibson. Three of the units are model number JS3BA-06KB and have 5-ton cooling capacity. The fourth unit is physically smaller but the specification sticker was not visible so capacity cannot be reported at this time. The units appear to be installed too close together and most likely do not comply with manufacturer minimum clearances for proper airflow. The mounting bracket also looks to be weathered and in poor condition and the structural integrity should be evaluated for the carrying load.

AC compressors installed on rear of building

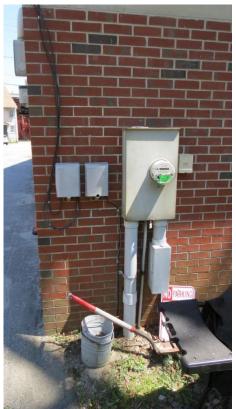
The electrical service does not meet NEC 708 Critical Operations Power Systems (COPS). This building should have the power system upgraded to conform to the NEC 708 where this facility is a critical operation for the City.

Service entrance meter
