CITY OF BATH VULNERABILITY ASSESSMENT AND ADAPTATION STRATEGIES

Bath, Maine Project No. 23138

MAY 31, 2024 REVISED JUNE 6, 2024

FINAL REPORT

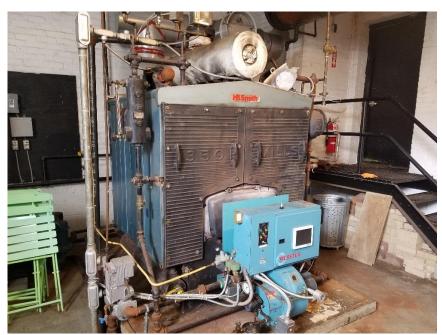
The plant consists of a single H. B. Smith 350 Mills steam boiler with eight sections rated for a gross output of 1,790 MBH. The boiler is fired with a Webster JB1C-07 dual-fuel burner that can burn either natural gas or #2 fuel oil. The boiler and burner are in working condition and serve as the primary source of heating for the building. There are signs of leaking on the water side of the boiler, but not to a significant amount. Most of the rust evident around the boiler is due to blowing down the mud drums which is standard maintenance for steam boilers. It appears that the breeching for the boiler was replaced recently, and the joints were fire caulked. According to nameplate data, the burner was manufactured in 2013; the age of the boiler is unknown but believed to be older than the burner.

Overall View of Boiler and Burner

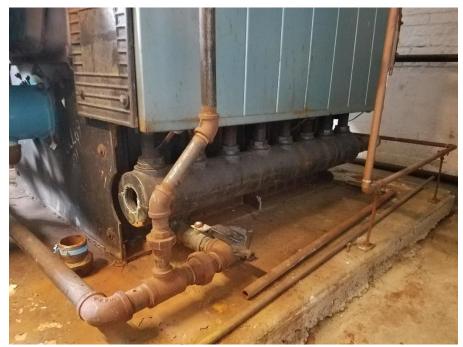
Rust Around Base of Boiler

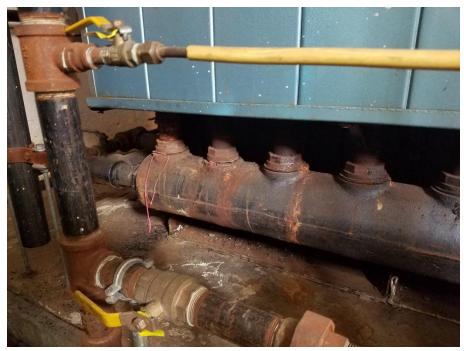
Leaking on Water Side of Boiler

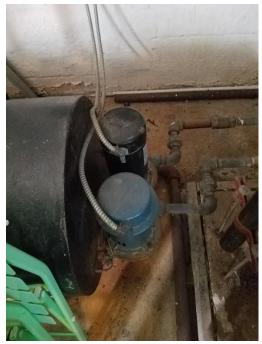
There is an existing condensate receiver with duplex pumps that serves the steam boiler. The tank looks to be the same vintage as the boiler, but the pumps were replaced during the life of the equipment. The pumps are in working condition and it does not appear that they have recently been leaking significantly. There is some rust on the floor near the pumps, but that may have been attributed to prior pumps that were replaced.

Existing Duplex Condensate Pumps

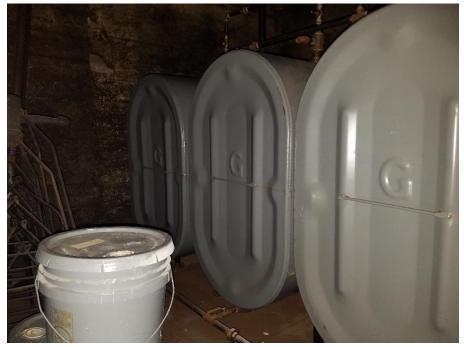
There are three (3) above ground oil storage tanks that are in very good condition. These tanks appear to have been installed recently, since they are much newer than the boiler and burner that they serve. The tank fill and vent piping appears to have been installed at the same time as the oil tanks since it is in very good condition.

Above Ground Oil Storage Tanks

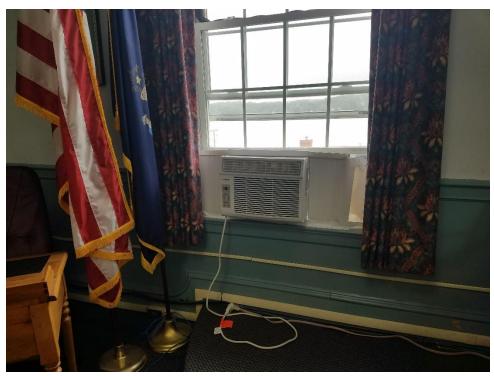
There are also occupied spaces that are cooled with window air conditioners. This type of equipment is not intended to be a long-term solution and would be discarded at the end of its useful life. There is also a

maintenance component associated with this equipment since they need to be physically installed and removed each year by staff.

Window Air Conditioner

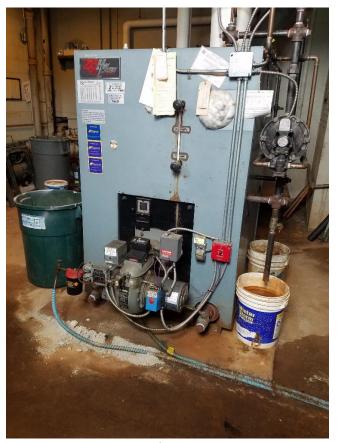
The plant consists of a single H. B. Smith 28 Series High Efficiency steam boiler with six sections rated for a gross output of 1,110 MBH. The boiler is fired with a Carlin 801CRD oil burner that burns #2 fuel oil. The boiler and burner are in working condition and serve as the sole source of heating for the building. There does not appear to be significant signs of leaking on the water or fire side of the boiler, and it appears to be in good condition. In the photo below, there is evidence of past water leakage from the sight glass. There is rust evident at the side of the boiler where blow down occurs, which is standard maintenance for steam boilers. The breeching for the boiler looks original and is in working condition. Joints do not appear to be sealed with fire caulk like the boiler at City Hall.

Overall View of Boiler and Burner

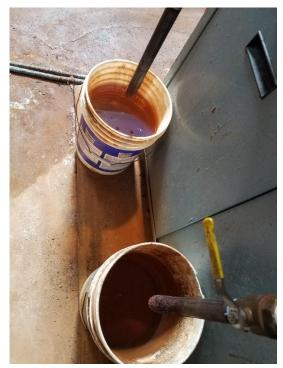
Rust from Boiler Blow Down

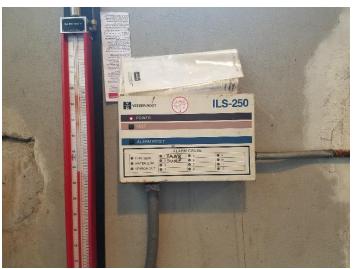
There is a single underground fuel storage tank in the parking lot adjacent to the boiler room. It is unknown when the tank was installed, or what condition the tank is in. There is a Veeder-Root underground tank monitoring system which appears to be in working condition.

Veeder-Root Underground Tank Monitoring System

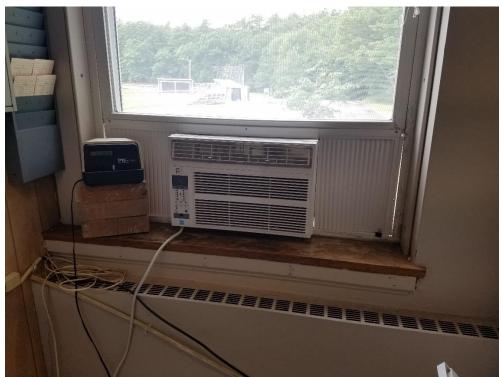
Some of the occupied spaces are cooled with window air conditioners. This type of equipment is not intended to be a long-term solution and would be discarded at the end of its useful life. There is also a maintenance component associated with this equipment since they need to be physically installed and removed each year by staff.

Window Air Conditioner

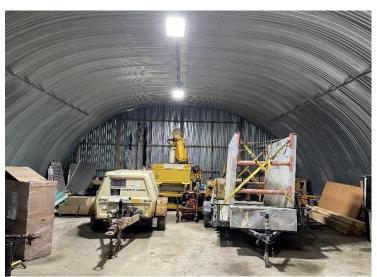
Based on a discussion with the DPW it appears this building has been moved to this site from a
former government works project and it is unclear whether the building has been engineered for
gravity and lateral loads as prescribed by the International Building Code.

Storage shed interior.
