CITY OF BATH

Bath, Maine PROJECT #20394

October 15, 2020

Fire and Police Facility Study

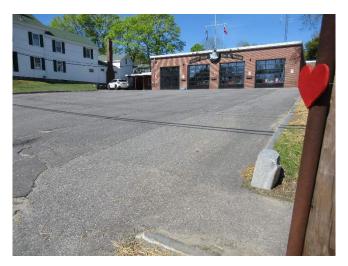
The building is located well above High Street enhancing views but presenting challenges for vehicular movements, stormwater runoff and snow plowing/ storage.

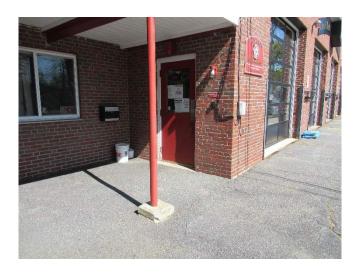
Pedestrian access to the site form High St. is along the apparatus apron area. Otherwise visitors park near the main entrance and access the entry along the parking area behind the parking spaces. There is no separate sidewalk or accessible route. Staff access is from the rear parking lot using paved sidewalks.

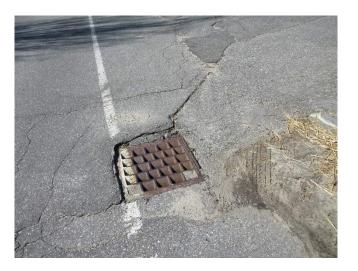
All surface run off from the building to High St. is collected along the street to a single catch basin at the north side of the driveway. The paved surface is about 90 ft. wide across the front of the building and at the street and 98 ft. deep. All runoff sheet flows down the very steep driveway and during heavy rains stormwater overtops the catch basin and flows into and across High St.

- 1. Separate stormwater and sanitary sewer.
- 2. Provide concrete slabs at doorways
- 3. Regrade snow storage areas to avoid meltwater runoff onto adjacent properties.

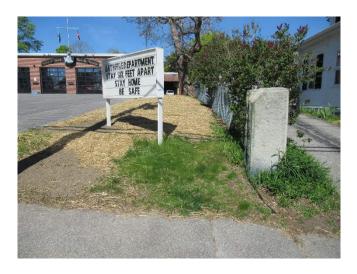
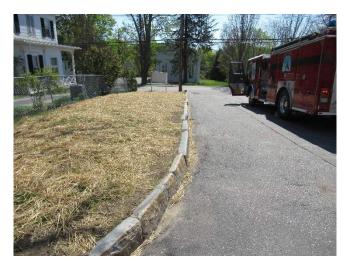
The site pavement extends nearly to adjacent property lines. Snow clearing and especially snow storage is difficult. The front driveway is plowed to the north and all snow piled on a narrow lawn area adjacent to the abutting property. With repeated snowstorms, snow must be hauled off site. Melt water drains partially onto the lowerlying, abutting property in addition to sheet flowing onto the driveway area. Keeping the driveway ice-free and cleared of snow is critical due to the steep grade.

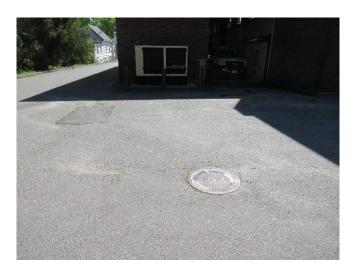
- Water Service
 - It is our understanding that water service is adequate for existing needs.
- Sanitary sewer
 - A sanitary sewer line crosses the rear parking lot and along the north side of the building excepting that it is partially routed under the building.

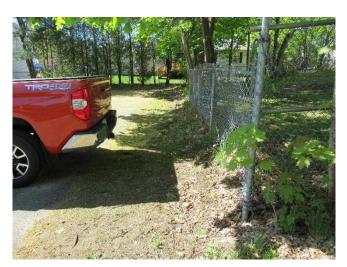
As noted above, there is minimal screening. Fencing is primarily chain-link fence. Where evergreen shrubs are provided along the northerly property line, it was not clear of those are on the abutting properties.

- 1. Review screening needs and where there is inadequate space for evergreen shrubs, provide secure, durable screen fencing.
- 2. Continue to repair damaged grass areas promptly.
- 3. Repair compacted area in the rear courtyard area and where necessary provide decorative paver or permeable paver surfacing for outdoor activities.
- 4. Continue maintenance of mature trees and removal of invasive trees such as Norway Maples.
- 5. If possible, investigate the use of permeable pavements and subsurface stormwater treatment to compensate in part for the lack of green space and impervious surfaces on-site.

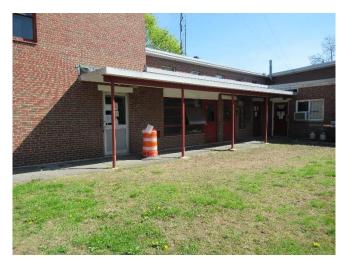
The lawn area on the north side of the driveway used for snow storage had been recently reseeded and mulched to repair damage from snow storage, compaction, and ice.

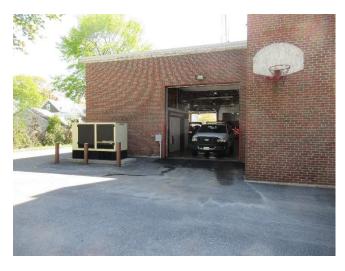
- Dumpster
 - A single dumpster is located at the northwest corner of the rear parking lot. It is not enclosed or screened.
- Generator
 - An emergency generator is located behind the building on the northerly side of the service bay doors. It is protected with bollards. The Chief noted that the noise from periodic scheduled cycling of the generator on and off will upset some abutters.

- Summary of Recommendations
 - 1. Screen the dumpster from abutting properties and provide a concrete pad and pipe bollards for protection.
 - 2. To the extent practicable, reduce noise levels from the generator and/ or provide additional screen planting to attenuate noise levels.

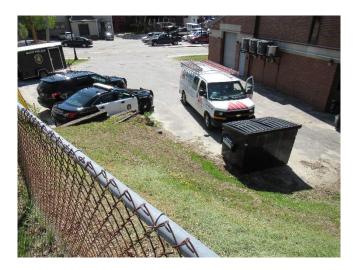
Patrol vehicle parking is not adequate – the total number of spaces needs to be determined however, there is not enough parking for both patrol vehicles (5-spaces) and personal vehicles or any additional vehicles in the rear parking lot. Parking for other staff and the public is only limited by the number of spaces available in the municipal parking lot. It would be preferable to have a separate parking area for staff.

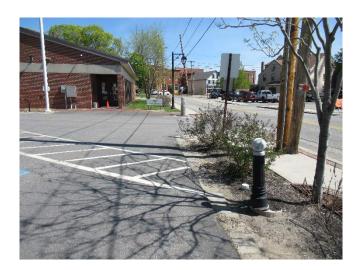
Pedestrian Circulation & Accessibility Access to the front of the building located on the south east corner and close to Water Street is convenient for the public and others using the municipal parking lot. The sidewalk to the building is accessible and paved with brick pavers. There is a narrow, paved and abruptly sloped separation between the sidewalk from Water St. to the building entrance and the municipal parking lot.

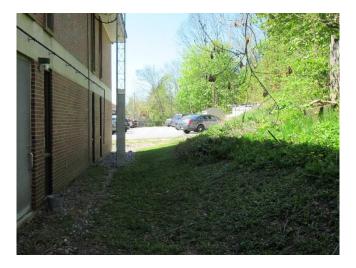
All parking lot pavement and driveways are asphalt. The rear parking lot is in fair condition; the municipal parking lot is in good condition. The brick sidewalk from Water St. to the main entrance is in fair condition with some uneven pavers.

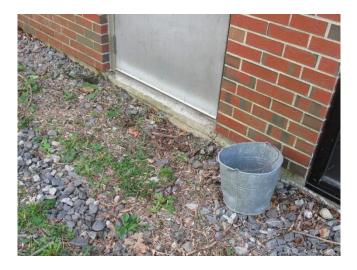
The main building entrance area is under cover with concrete slab pavement which appears to have adequate surface drainage to the abutting lawn. Several other doorways either have asphalt pavement to them or step out onto the crushed stone drip edge.

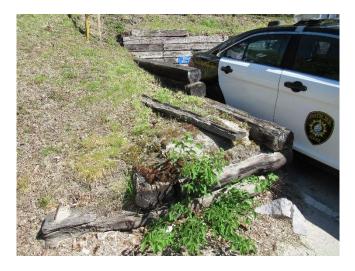
A wood retaining wall is located in the rear parking lot along Elm St. It is in very poor condition and should be replaced with a more substantial structure.

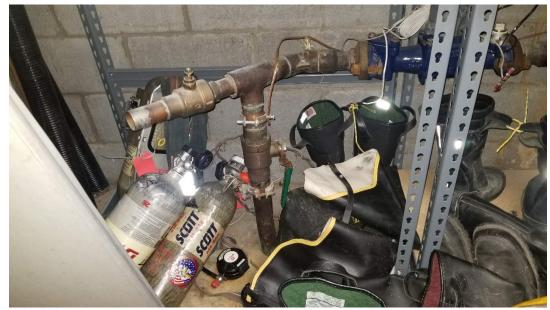
Water Entrance

The water service enters through the floor in the storage below the mezzanine at the back of the station. A 2" copper water service is connected to a water meter and reduced pressure zone backflow preventer. The copper riser has a tee with a valved off cut pipe with no connection. Water to the building and fire truck fill piping is served from this location.

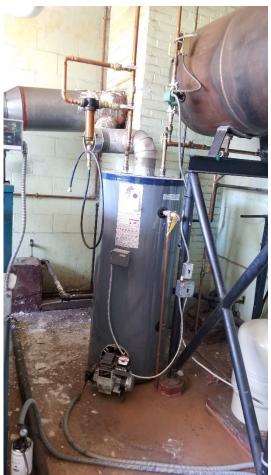
Oil Fired Water Heater

The domestic water heating consists of an oil fired 50 gallon water heater with 152,000 btuh input. The water heater was installed in 2012. The water heater utilizes atmospheric room combustion. The water heater is connected to the building without a thermostatic mixing valve. The water heater control is set to deliver the desired water to the building. The stored water temperature of the tank is unknown. It is estimated the water heater set to 125°f. A circulating pump connected to the hot water delivery piping maintains hot water in the pipes. The Aquastat controlling the circulating pump is only set to 85°f. Temperature should be maintained closer to 115°f. There is water filter on the hot water outlet piping of the water heater. The filter reduces sediment from the tank to the plumbing fixtures.

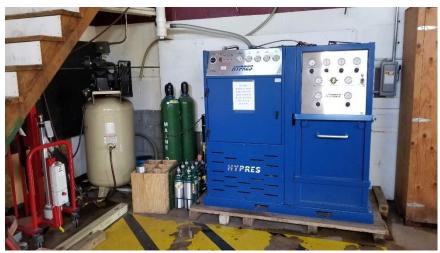
The back bay has a vertical air compressor, wash sink and laundry equipment. The wash sink has a faucet with attached eyewash spout. The eyewash does not meet ANSI standard Z358.1 due to the lack of water tempering to the eyewash.

A HYPRESS compressed breathing air cabinet is located near the house air compressor charges backpack tanks. The house air compressor is located under the stairs to the mezzanine. Compressed house air is piped around the garage bays through threaded steel pipe to serve the trucks. Pressure is maintained between 115 psi and 120 psi. Steel piping can cause sediment from scaling to interfere with clean air discharge. An aluminum piping system offers no scaling inside the pipe. The equipment and piping appear to be in good working condition.

Air Compressor and Breathing Air Compressor with Oxygen Storage (green) Cylinders.

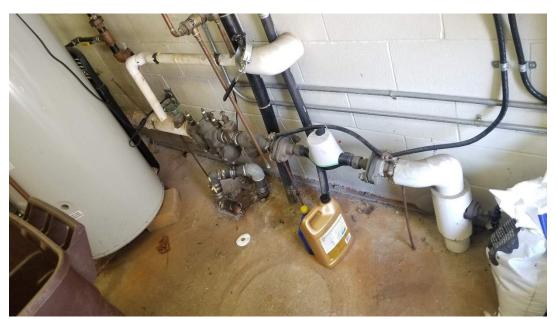
The water service enters the emergency generator room. A 2" copper rises up through the slab near the outside wall. The service has a water meter and reduced pressure zone backflow preventer. The piping is copper and grounded. There is a floor drain nearby. A small water line is connected to the emergency generator for cooling. The generator is slated to be replaced.

Water Entrance

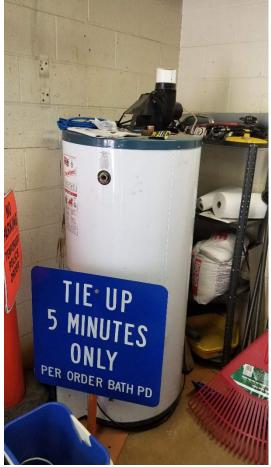
Abandoned Water Heater

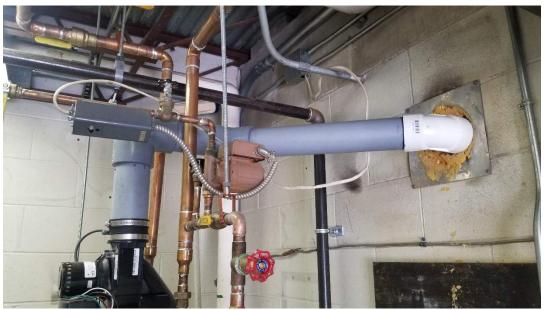
The domestic water heating consists of a natural gas fired 75 gallon water heater with 72,000 btuh input. The water heater was installed in 2013. The water heater is a sealed combustion unit providing high efficiency. The water heater is connected to the building without a thermostatic mixing valve. The water heater control is set to deliver the desired water to the building. The stored water temperature of the tank is unknown. It is estimated the water heater set to 125°f. based on the setting of the Honeywell controller. A circulating pump connected to the hot water delivery piping maintains hot water in the pipes. The Aquastat controlling the pump was set to 65°f. It is unknown how and when the circulating pump operates. The flue for the water heater is CPVC but has one PVC elbow before transitioning back to CVPC outside. The PVC elbow should be replaced with CPVC.

Water Heater Exhaust Flue

- Replace the PVC elbow at the gas water heater with CPVC.
- Remove the abandoned L.P. gas piping on the exterior of the back wall.
- Paint the exterior gas piping a color chosen by the owner to prevent further corrosion of the exposed steel gas piping.

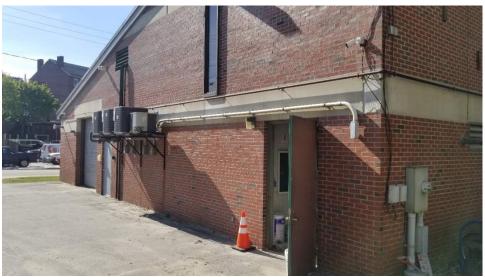
The building is served by Maine Natural Gas. The gas service is located outside the water heater room. The gas service enters the building at a 7" water column. Piping to the attic air handing equipment is exposed around the exterior of the building. The exposed piping is not painted to protect from corrosion. An odor of gas was found in the water heater room during the survey. A contractor was called and inspected the system the same day. It is assumed the gas leak was repaired. There is an abandoned liquid propane pipe mounted on the wall above the gas meter. This line has no purpose and should be removed from the building.

Exposed Gas Pipe at Top of Concrete Band

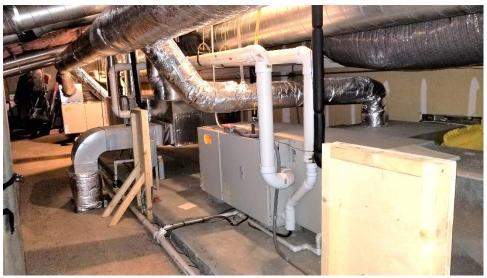
There are four units in the attic which are gas fired. The natural gas pipe on the exterior of the building enters the garage and runs along the wall of the attic. Each unit is connected with a flexible stainless-steel supply line. There was no odor witness in the attic. Each unit also has two condensate connections. One drain is from the exhaust flue and the other is from the drain pan within the unit. The PVC condensate drain runs across the floor with very little slope and discharges to the service sink in the garage via an air-break. The PVC intakes and flues connect to a concentric fitting which exits the building through one separated pipe within a pipe. There are no leaks on the condensate drainage piping.

Attic Air Handling Equipment

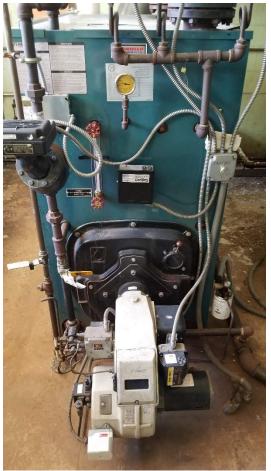
The boiler and water heater share the same flu, which are connected using a wye fitting before entering the chimney stack. Combustion air is provided to the boiler room through a wall louver. The boiler does not have a separate barometric damper from the water heater.

Existing Burnham boiler

The oil-fired, steam heating system while functioning has needed major repair over the years. The steam distribution piping is most likely all original and may have significant leaks which has caused the system to run low on water. Replacing all steam distribution with a hot water system is recommended. The boiler and controls may be suitable for a hot water conversion. The steam radiators may also be suitable to convert to hot water distribution though it is unlikely. A heating analysis must be performed on the building and the radiators to confirm the existing radiators have capacity to adequately heat the space using lower temperature water instead of steam. If a system conversion to hot water was considered replacing the existing radiators with more efficient radiators may be prudent. The benefits to a hot water system conversion would be increased system efficiency resulting in lower maintenance and operational costs and improved temperature control.

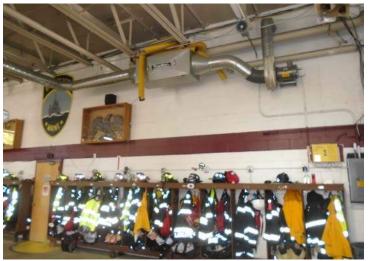
The main apparatus bays are ventilated with a Plymovent system for five vehicles. There is a sixth emergency vehicle that does not have an exhaust hose connection to the Plymovent system. According to the Chief, adding an additional connection for that vehicle has been discussed and would be required.

Plymovent system in main apparatus bay

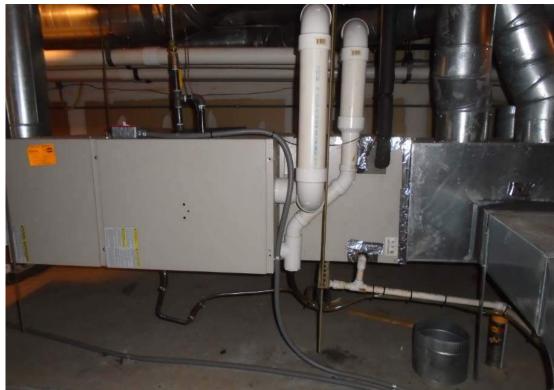
There are four air handling units manufactured by Kelvinator installed in the attic. Three units are model number G5RC 120C-20C with heating capacity rating of 120,000 BTU/hr and 1710 CFM airflow on High fan speed at maximum external static pressure of 0.8 in. W.G. One unit is model number G6RC 080C-16B with heating capacity rating of 80,000 BTU/hr and 1290 CFM airflow on High fan speed at maximum external static pressure of 0.8 in. W.G. It was reported that the systems were installed sometime prior to 2005. The systems seem generally in good condition except for the condensate drain on one of the units. The drain was installed poorly and without the use of proper fittings. The installation does not have a negative effect on system performance, however.

Existing gas furnace air handler and air conditioning coil

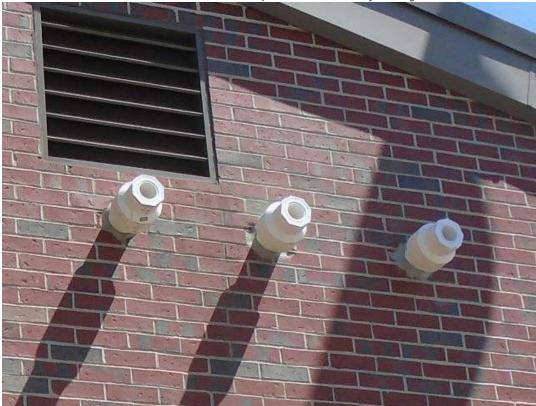
Coaxial exhaust and combustion air intake vents are installed. Three on the south-facing wall and one on the north facing wall. Condensate drains for the air conditioning coil, and the furnace exhaust are collected from each system and drained to a sink in the cruiser garage.

Coaxial exhaust and combustion air fittings on exterior of building

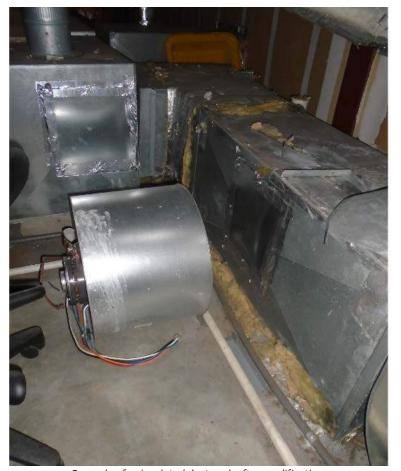
Heating and cooling is distributed throughout the building through ductwork. Ductwork is mostly insulated in the attic but there are some sections where modifications to the ductwork was conducted and insulation was not replaced. There are three zones for the first floor and the second floor is the fourth zone. Honeywell programmable thermostats are installed throughout.

Example of uninsulated ductwork after modifications

At a minimum, the R-22 condenser units should be replaced. Duct work should be evaluated and improvements like sealing and re-insulating should also be considered.

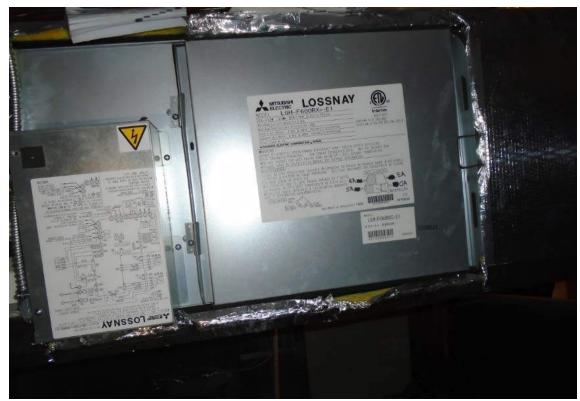
Lossnay Unit

It was reported that the Lossnay system requires a manual reset whenever power is lost. It also seems that the Lossnay controller is not interlocked with the air handler units. Evaluating the controls for the Lossnay would be recommended. Providing an accessible main controller to the police station as well as interlocking the air handling units to run on low fan speed whenever the Lossnay is operational is also recommended.

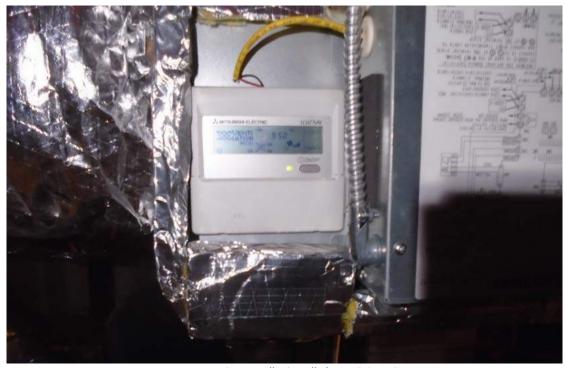
Lossnay main controller installed on unit in attic

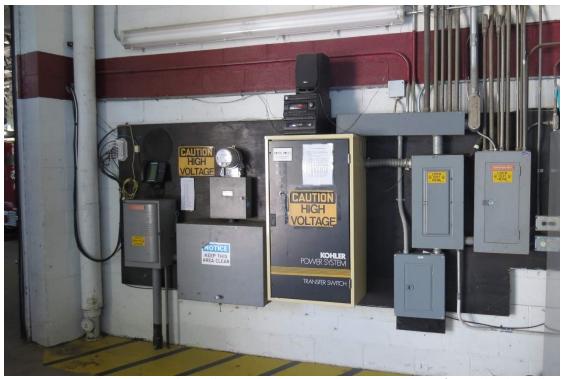
The electrical service does not meet NEC 708 Critical Operations Power Systems (COPS). This building should have the power system upgraded to conform to the NEC 708 where this facility is a critical operation for the City.

Service entrance disconnect switch–CT cabinet with utility meter above- automatic transfer switch - electrical distribution (three panelboards)

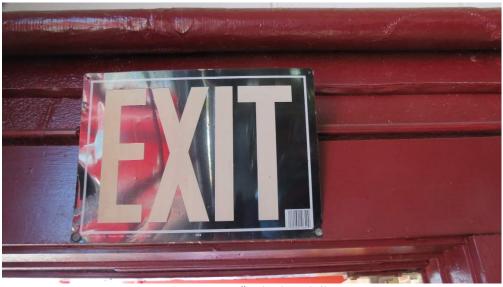
The exit signs are the non illuminating type. The are no emergency battery units in the building.

Non-Illuminating Exit Sign

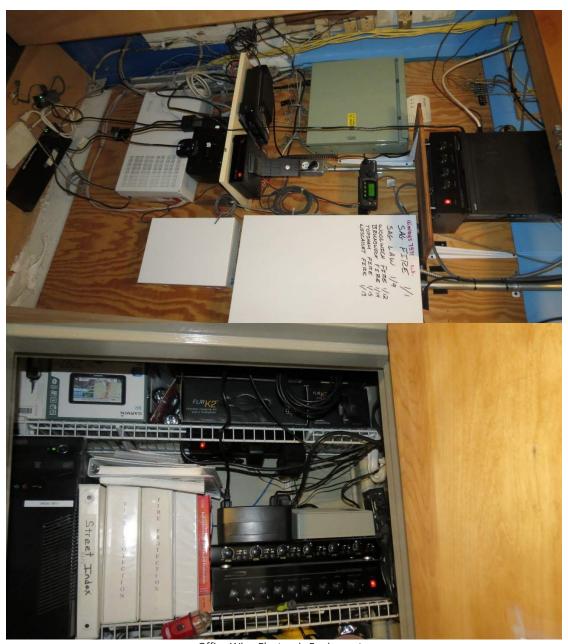
The telephone/data demarcation is in a closet within the bedroom wing. Other electronic equipment is in a closet in the office wing of the building. The building has a radio tower on the roof of the building. This building being built in the 1950's was not designed for today's technology. The equipment has been retrofitted into the building in closets that are two small based on today's standards.

Office Wing Electronic Equipment

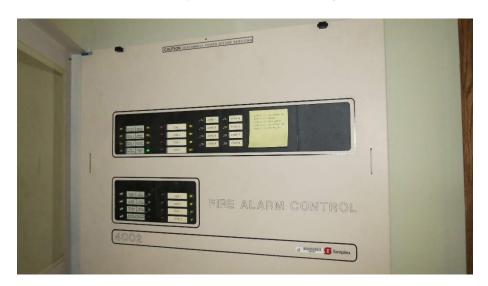
Fire Alarm:

There is a conventional 8 zone Simplex fire alarm panel. The notification appliances (horn/lights) do not meet ADA. There are pullstations in the building.

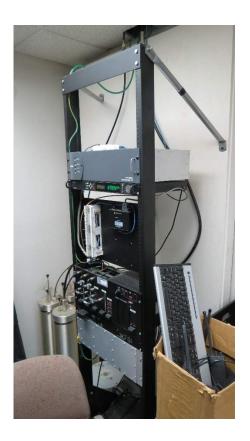
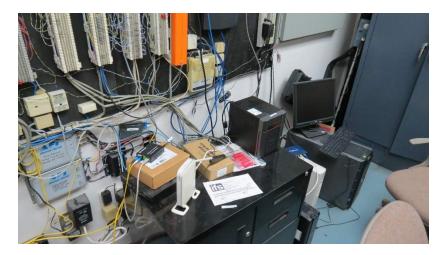
Technology:

The electronic equipment is in a closet on the second floor of the building. This is also the telephone demarcation point. The building has the radio equipment in the room.
