CITY OF BATH VULNERABILITY ASSESSMENT AND ADAPTATION STRATEGIES

Bath, Maine Project No. 23138

MAY 31, 2024 REVISED JUNE 6, 2024

FINAL REPORT

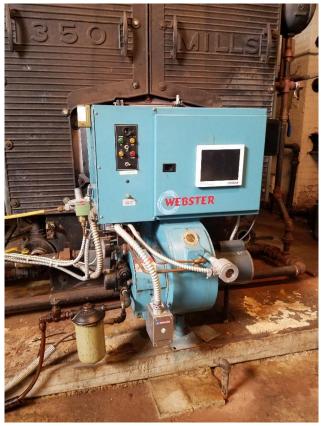
Dual-Fuel Burner

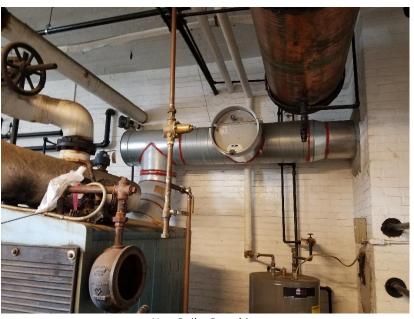
New Boiler Breeching

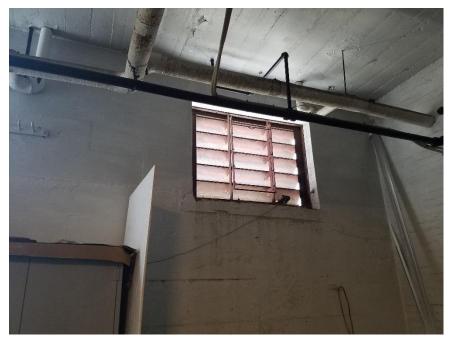
no actuator on the damper and the block of wood could be easily removed thus preventing the transfer of combustion air from outside.

Boiler Room Combustion Air Opening

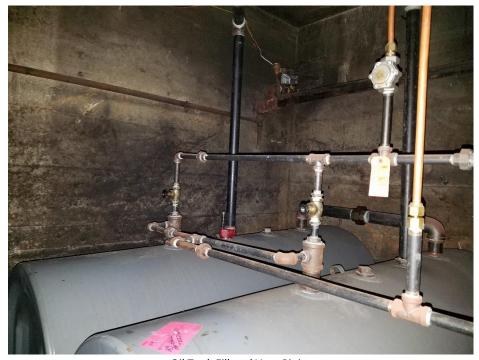
Oil Tank Fill and Vent Piping

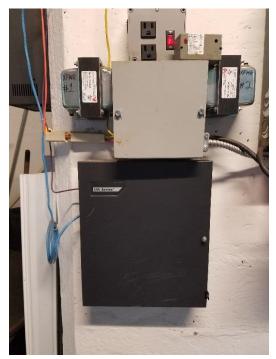
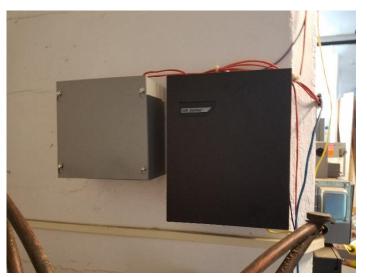
In the boiler room, there are Schneider Electric DDC panels that provide automation to the boiler plant and building heating elements within the occupied spaces. During our site visit, it was noted that the building controls are not fully automated, but that is a goal for the City of Bath.

DDC Control Panel

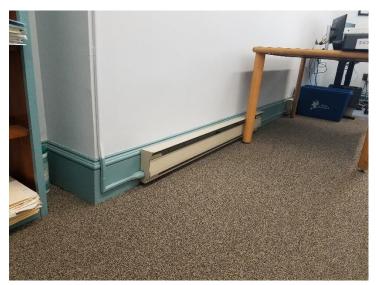
There is also electric baseboard heating at some locations within the building, that is controlled via an electric stand-alone thermostat. This equipment appears to be in working condition and appears to heat spaces where the steam heating is not present. Utilizing local control thermostats will potentially consume more energy since they could be left energized during unoccupied hours and there is no limiting to the temperature setpoint.

Electric Baseboard Heating Element

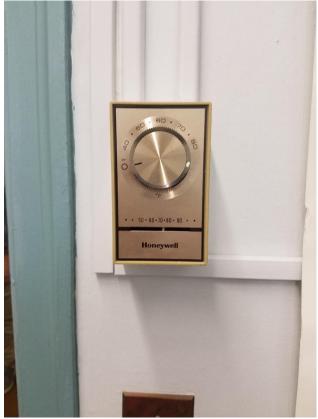
Electric Stand-Alone Thermostat

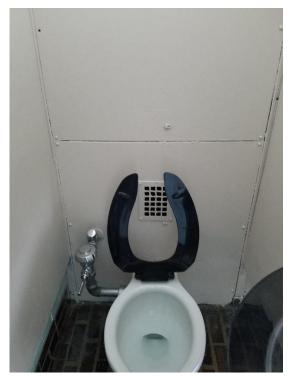
Toilet rooms and other spaces are exhausted either passively with roof vents or actively with exhaust fans at the roof level. It is unknown if the code required exhaust flow rates are being achieved with the existing system.

Wall Mounted Toilet Exhaust Grille

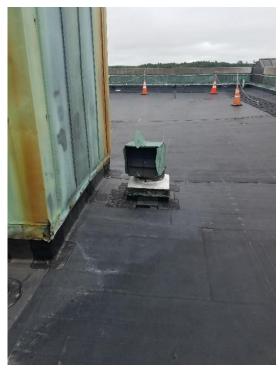
Roof Mounted Exhaust Vent or Fan

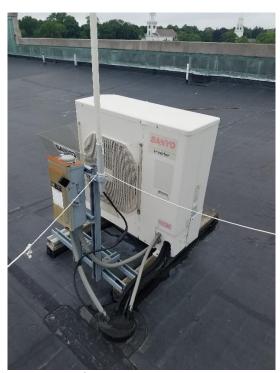
Some of the occupied spaces are cooled with split system heat pumps and air conditioners. One of the condensing units is located on the roof, and the others are located under an accessible ramp at the ground level. All this equipment is locally controlled with no communication to the DDC system.

Roof Mounted Condensing Unit

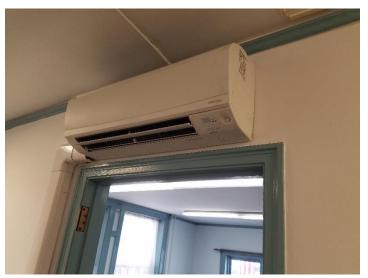
Wall Mounted Evaporator Unit

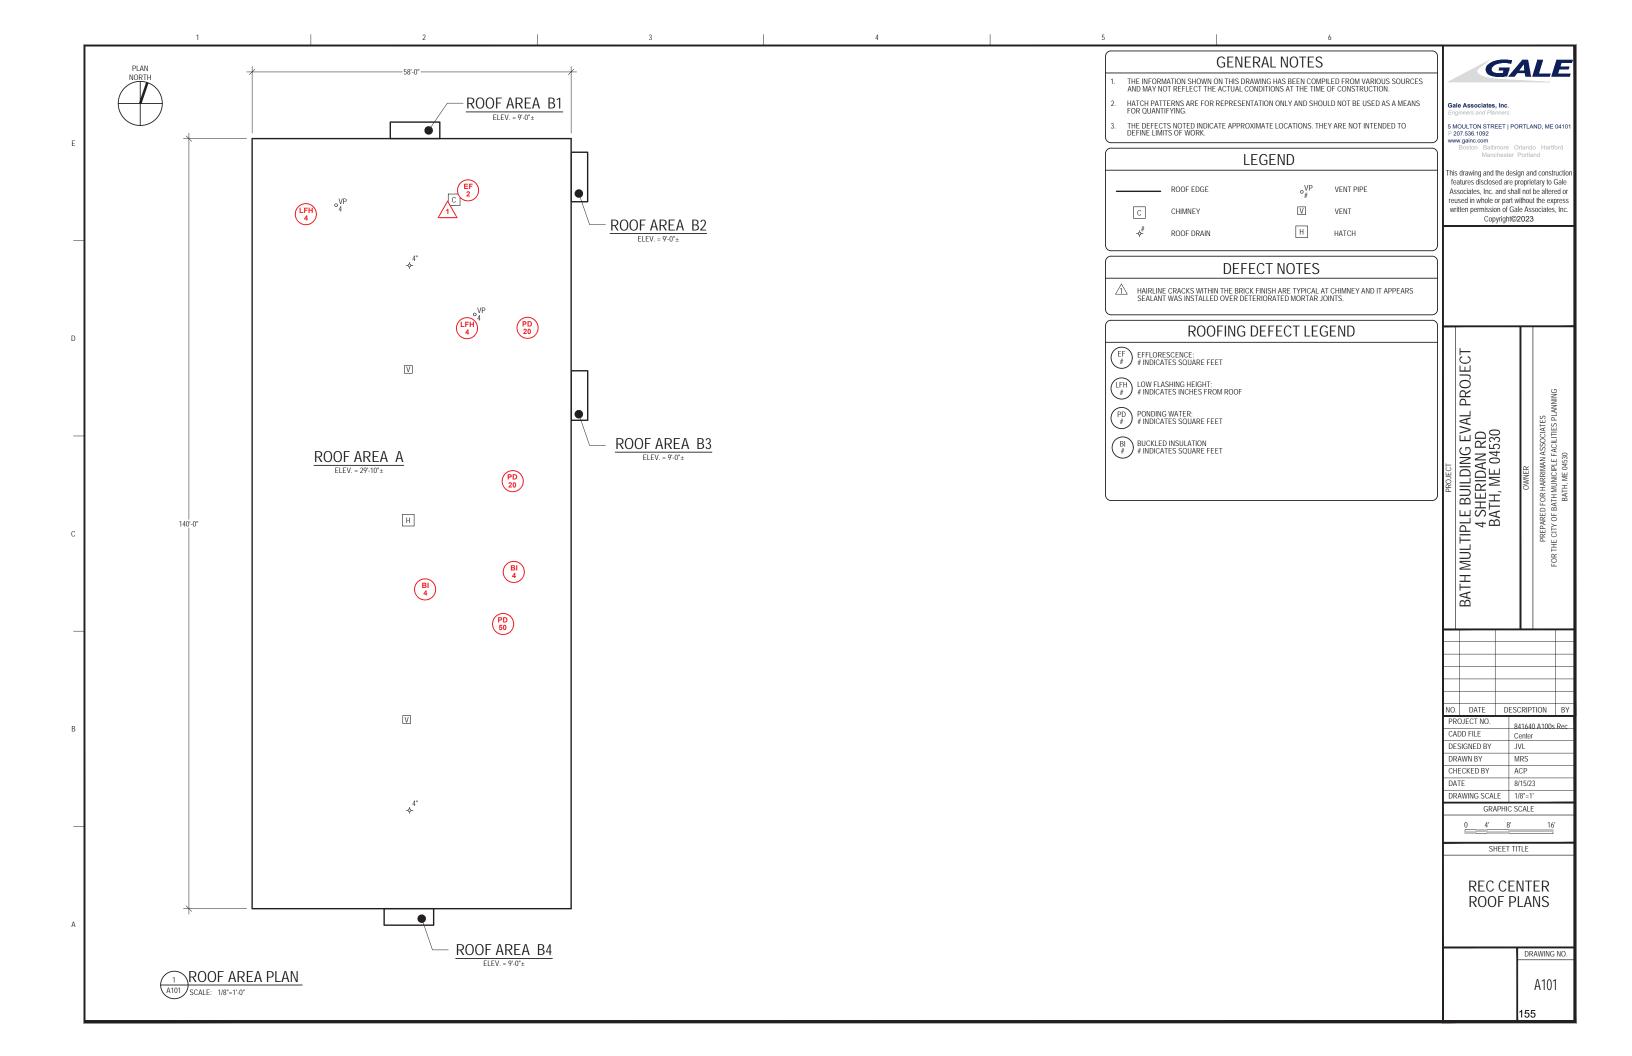
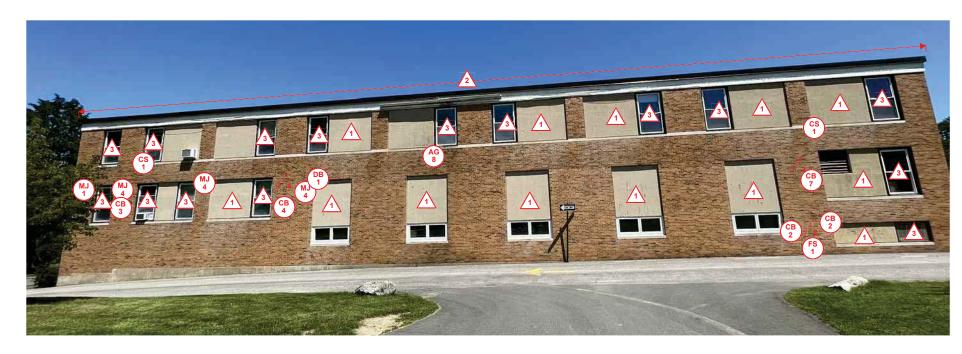
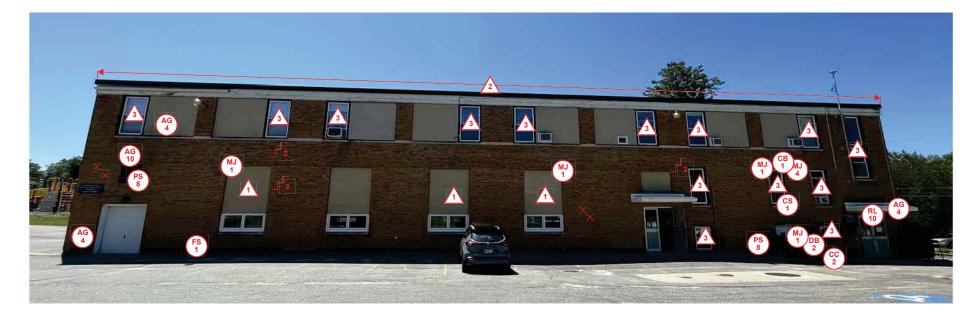
> DRAWING NO. A20

A PEELING PAINT TYPICAL AT WOOD WINDOW FRAME

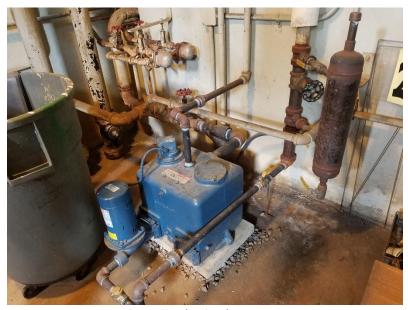
Existing Simplex Condensate Pump

There is an existing condensate receiver with a single pump that serves the steam boiler. This equipment looks to be in excellent condition and appears to have been replaced recently. You can tell that the piping connected to the receiver and pump is much newer than the rest of the piping.

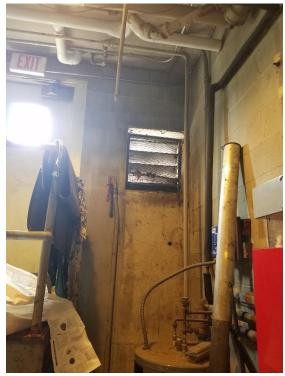
Boiler Room Combustion Air Opening

Combustion air is delivered through a single wall opening high above the floor of the boiler room. There is a backdraft damper, within the opening that appears to be propped open with a piece of wood or some other similar material. The 2015 International Mechanical Code (IMC) states that oil-fired appliances shall comply with NFPA 31 regarding combustion air requirements. Paragraph 5.5.1 of the 2024 Edition, states for commercial installations there shall be a permanent opening to the outdoors sized at least 1 square inch per 4,000 Btu of total input rating. Based upon the input rating of the boiler, the opening appears to be adequately sized to meet the code requirements.

The 2015 IMC also states that if volume, smoke, or fire dampers are provided with the combustion air opening, they shall be interlocked with the firing cycle of the associated appliances; manual dampers are not allowed. The current installation does not have any dampers which does meet the intent of the code.

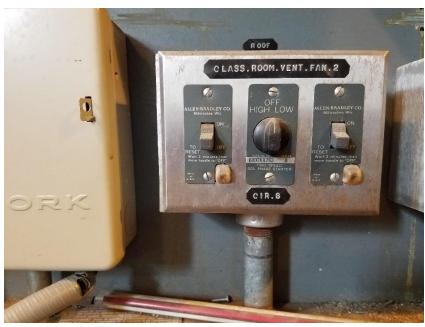
Motor Rated Manual Switches

Air handling equipment within the building is enabled/disabled and controlled with motor rated manual switches inside the boiler room. There are also electric time clocks associated with the exterior lighting and the day/night setback of building ventilation systems.

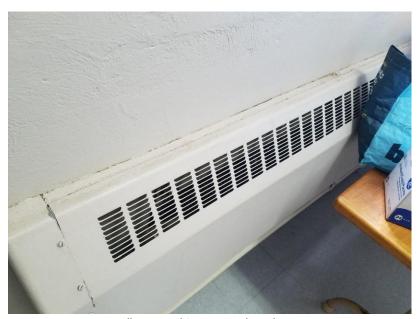
Wall Mounted Steam Baseboard Heater

The building receives heat from the boiler plant through steam baseboard heaters installed at the perimeter. The baseboard heating is wall mounted and in working condition.

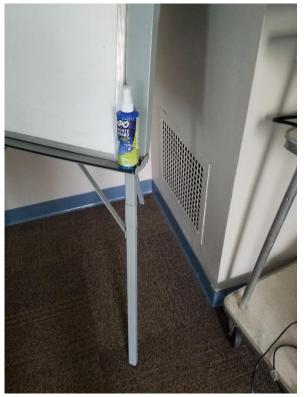
Wall Mounted Exhaust Grille

Toilet rooms and spaces that were previously used as classrooms, are exhausted passively with roof vents at the roof level. It is unknown if the code required exhaust flow rates are being achieved with the existing system.

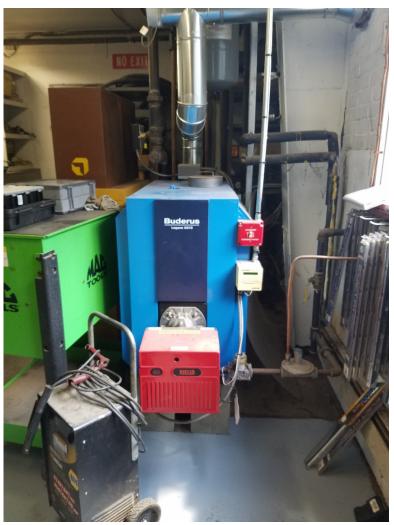
Overall View of Boiler and Burner

The plant consists of a single Buderus hot water boiler rated for a gross output of 294 MBH. The boiler is fired with a Riello model 40 gas burner that burns propane. The boiler and burner are in very good condition and provide heat to the DPW Main Office. The boiler is vented through the side wall of the building, to a vertical stack that terminates above the roof. The breeching and stack look to be in good condition.

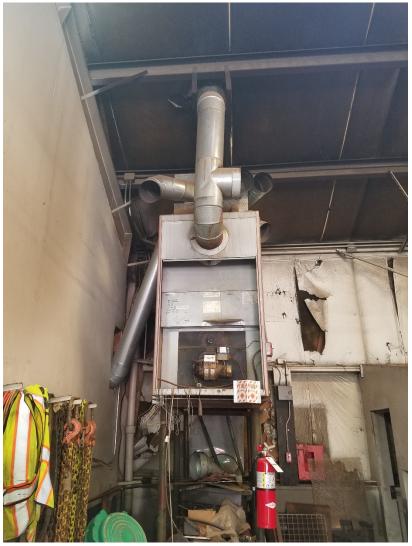
Oil-Fired Furnace

Inside the vehicle storage garage, there is a pair of oil-fired furnaces to provide heating for any staff working in that area.

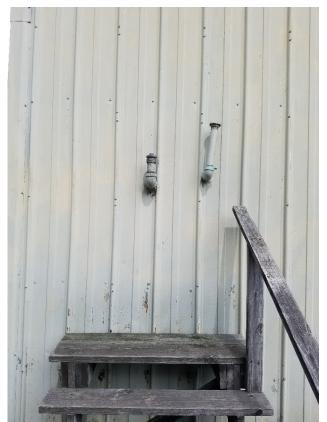
Oil Tank Fill and Vent Lines

Propane tanks store fuel for the Buderus boiler and are described within the plumbing section of the report. The oil-fired furnaces are served from an above ground oil tank within the building with fill and vent piping outside. There is a day tank up high in the mezzanine which directly supplies the furnaces.

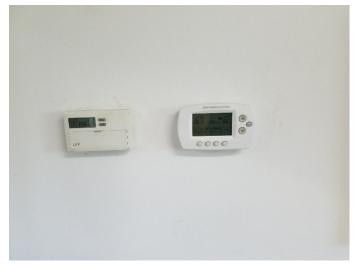
Heating System Thermostat and Heat Pump Thermostat

The DPW Main Office uses programmable thermostats to control heat for each zone. The hot water unit heaters each have a well mounted aquastat that turns on the associated fan if the water temperature is above setpoint. The oil-fired furnaces are each controlled with a local thermostat.

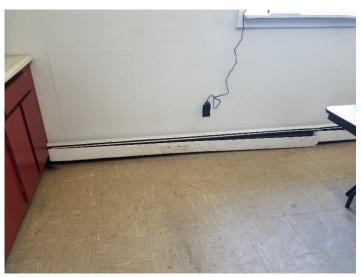
Wall Mounted Hot Water Baseboard Heater

The DPW Main Office receives heat from the boiler plant through hot water baseboard heaters installed at the perimeter. The baseboard heating is wall mounted and in working condition.

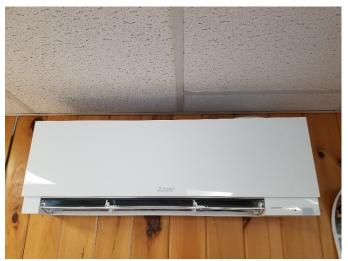
The DPW Main Office is air conditioned with a ductless split heat pump. The indoor evaporator units are wall mounted, with stand alone electronic thermostats for control. The outdoor condensing unit is wall mounted up high over a window on the exterior of the building.

Wall Mounted Indoor Evaporator

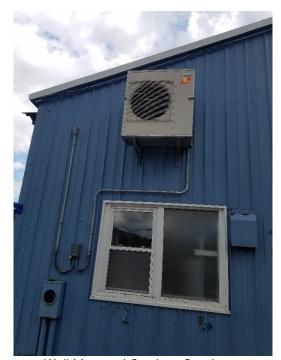
Wall Mounted Outdoor Condenser
